INDEX TO SUSPENSION AND HALF AXLES

SERVICE BULLETIN# 70

DS 19 - ID 19 CONFORT - ID 19 STATION WAGON

ANTI-ROLL BAR KNUCKES

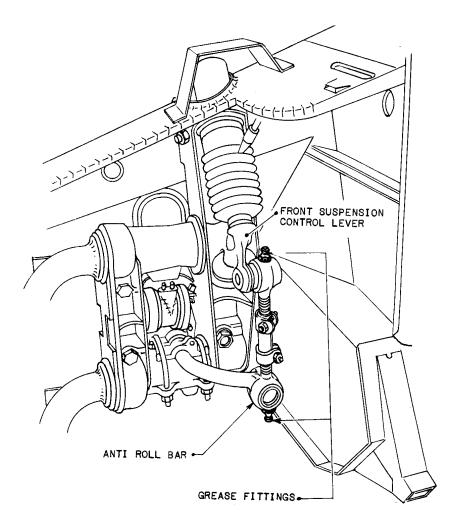
The anti-roll bar knuckles as well as the front suspension control levers are now equipped with grease fittings.

In order to reach these grease fittings it is necessary to remove the front fenders and both upper and lower protection shields (Parts 1# D 434-5; D 434-5A; D 434-106; D 434-107). The greasing of these knuckles must be performed at the 300 mile inspection and thereafter everytime that shields are to be removed. Chassis grease is to be used.

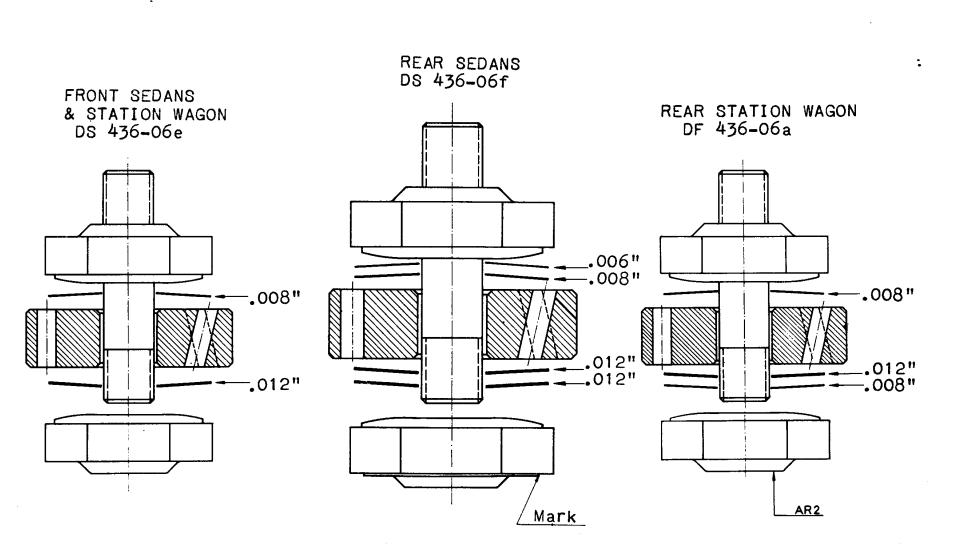
SHOCK ABSORBERS

On the cars now leaving our plant, modified shock absorbers are installed. The new shock absorbers have a hole of 0.079" or 2mm on the central body piece parallel to the axis. The flow control shims are of the same thickness as the previous ones except that they are slightly dome shaped. The shims are to be mounted as shown on diagram.

Shims of 0.013" (0.03 mm) are no longer used.

The nuts differ only by their outer bevel.

It is possible to install new shock absorbers instead of the old ones. When installing a new type shock absorber, always change the shock on opposite side, i.e. exemple: if a new type shock is installed on left front, install a new type shock on right front. Same applies to rear.

NOTE: It is preferable to replace all 4 units at the same time.

The tightening torque of the nuts is I4.5 ft/lbs or 2 m/Kgs The tightening torque of the shock absorber assembly on the suspension sphere is 11.5 ft/lbs or 1.6 m/Kgs. It is imperative to respect these torques. The use of a torque wrench is absolutely required.

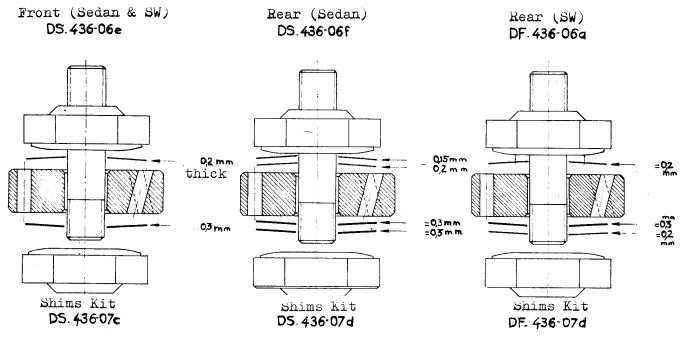
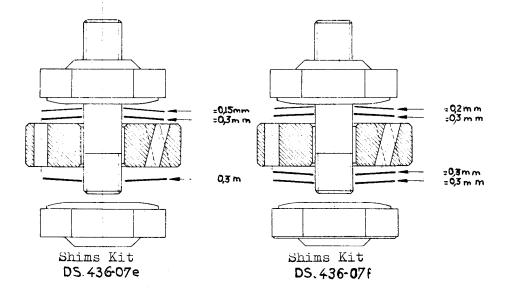
Our Parts Department has now available shock absorber shim kits for normal (original equipment) or heavy duty.

- These shims may be used on the same shock absorber body provided the plate, stud and nuts are in good condition. The kits are adaptable only to the shock absorbers announced in service bulletin # 83.
- The assembly sequence is shown on the attached sketches. The method of assembly is explained in bulletin #83, and repeated below.
 - The shims are bent across a diameter. The concave side MUST face the plate. It is not necessary to have the shim center line in the same direction.
 - The tighting torque of the cap nuts is 15 ft.lbs.
 - Assemble the complete shock absorber to the sphere with I2 ft/lbs of torque.

BOTH FRONT SHOCK ABSORBERS MUST BE ABSOLUTELY IDENTICAL. THE SAME APPLIES TO THE REAR. HOWEVER, THE FRONT ASSEMBLY IS NOT THE SAME AS THE REAR.

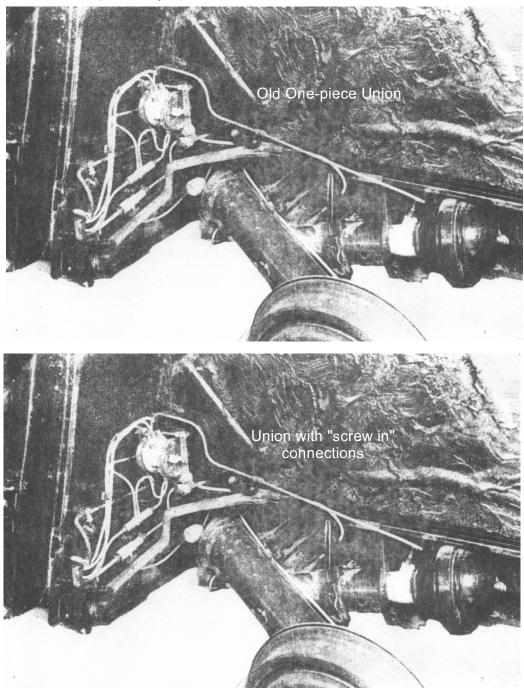
The connecting union of the left rear suspension is modified on the above mentioned models. It is replaced by a new union with "screw-in" connections.

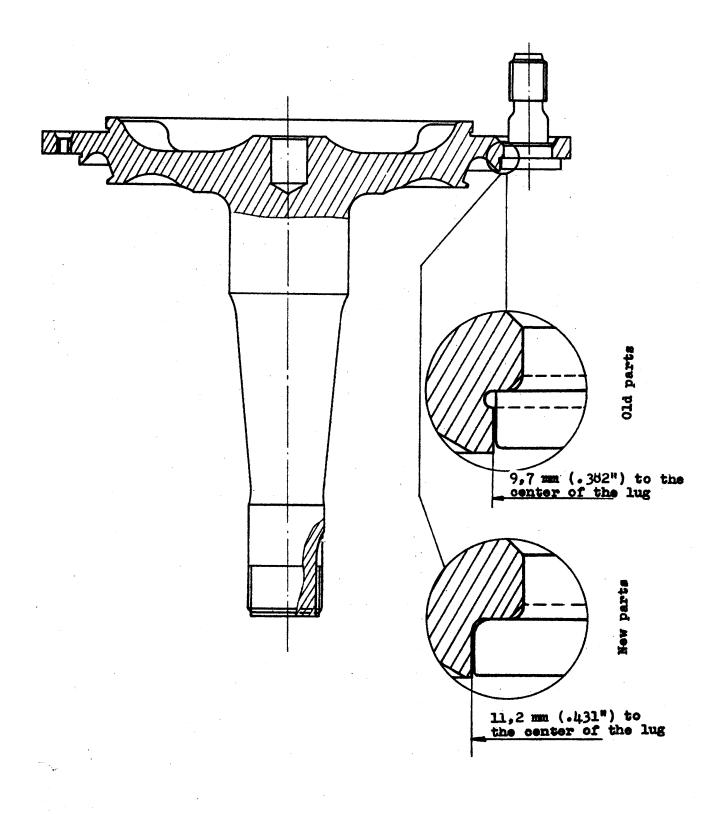
New lug

The wheel lugs, rear wheel spindles and hubs of the front pivots are modified.

- The assembly of a new wheel lug on on old rear spindle is not possible. The assembly of an old type lug on a new rear spindle is not possible.
 - The replacement of a wheel lug on a pivot is not possible. It is necessary to exchange the pivot.

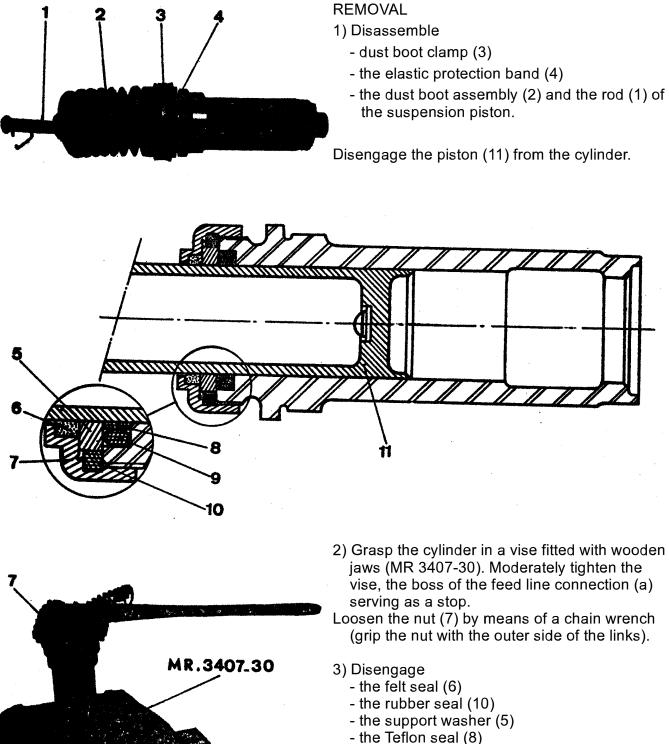
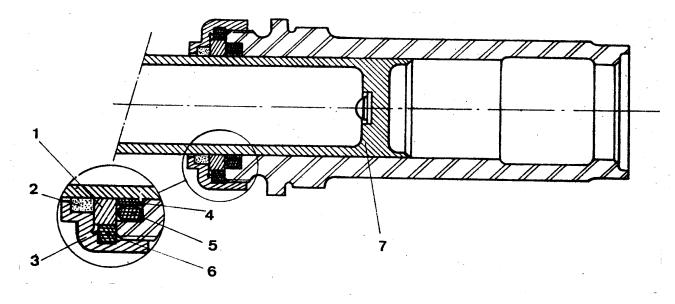
RECONDITIONING A SUSPENSION CYLINDER (with Teflon seals and square cross section "O" rings) RECONDITIONING A SUSPSION CYLINDER (with a ring seal securing of the nut)

The sealing of the suspension cylinders is now modified. A squared cross-section "0" ring assures the sealing between the body of the cylinder and the interior surface of the nut.

- In the case of shallow scoring, a slight resurfacing of the piston is tolerated using abrasive paper No 600 dipped in alcohol. Carefully wash it with alcohol and dry it with compressed air.
- 5) Coat the piston with the special liquid used in the hydraulic circuits.

Place the Teflon seal (4) on the lower part of the piston. (Be careful not to deform the seal).

Place the "0" ring (5), soaked in hydraulic fluid, into the shoulder of the cylinder.

Engage the piston (7) into the cylinder.

- 6) Mount the support washer (1) on the piston and set the Teflon seal in place by forcibly bearing on the support washer until it comes in contact with the cylinder.
- 7) Set into the nut (3) the felt seal (2), impregnated with hydraulic fluid, and the rubber seal (6).
