**TECHNICAL
INFORMATION**

CITROËN CARS CORPORATION

INDEX TO TRANSMISSIONS / DRIVESHAFTS

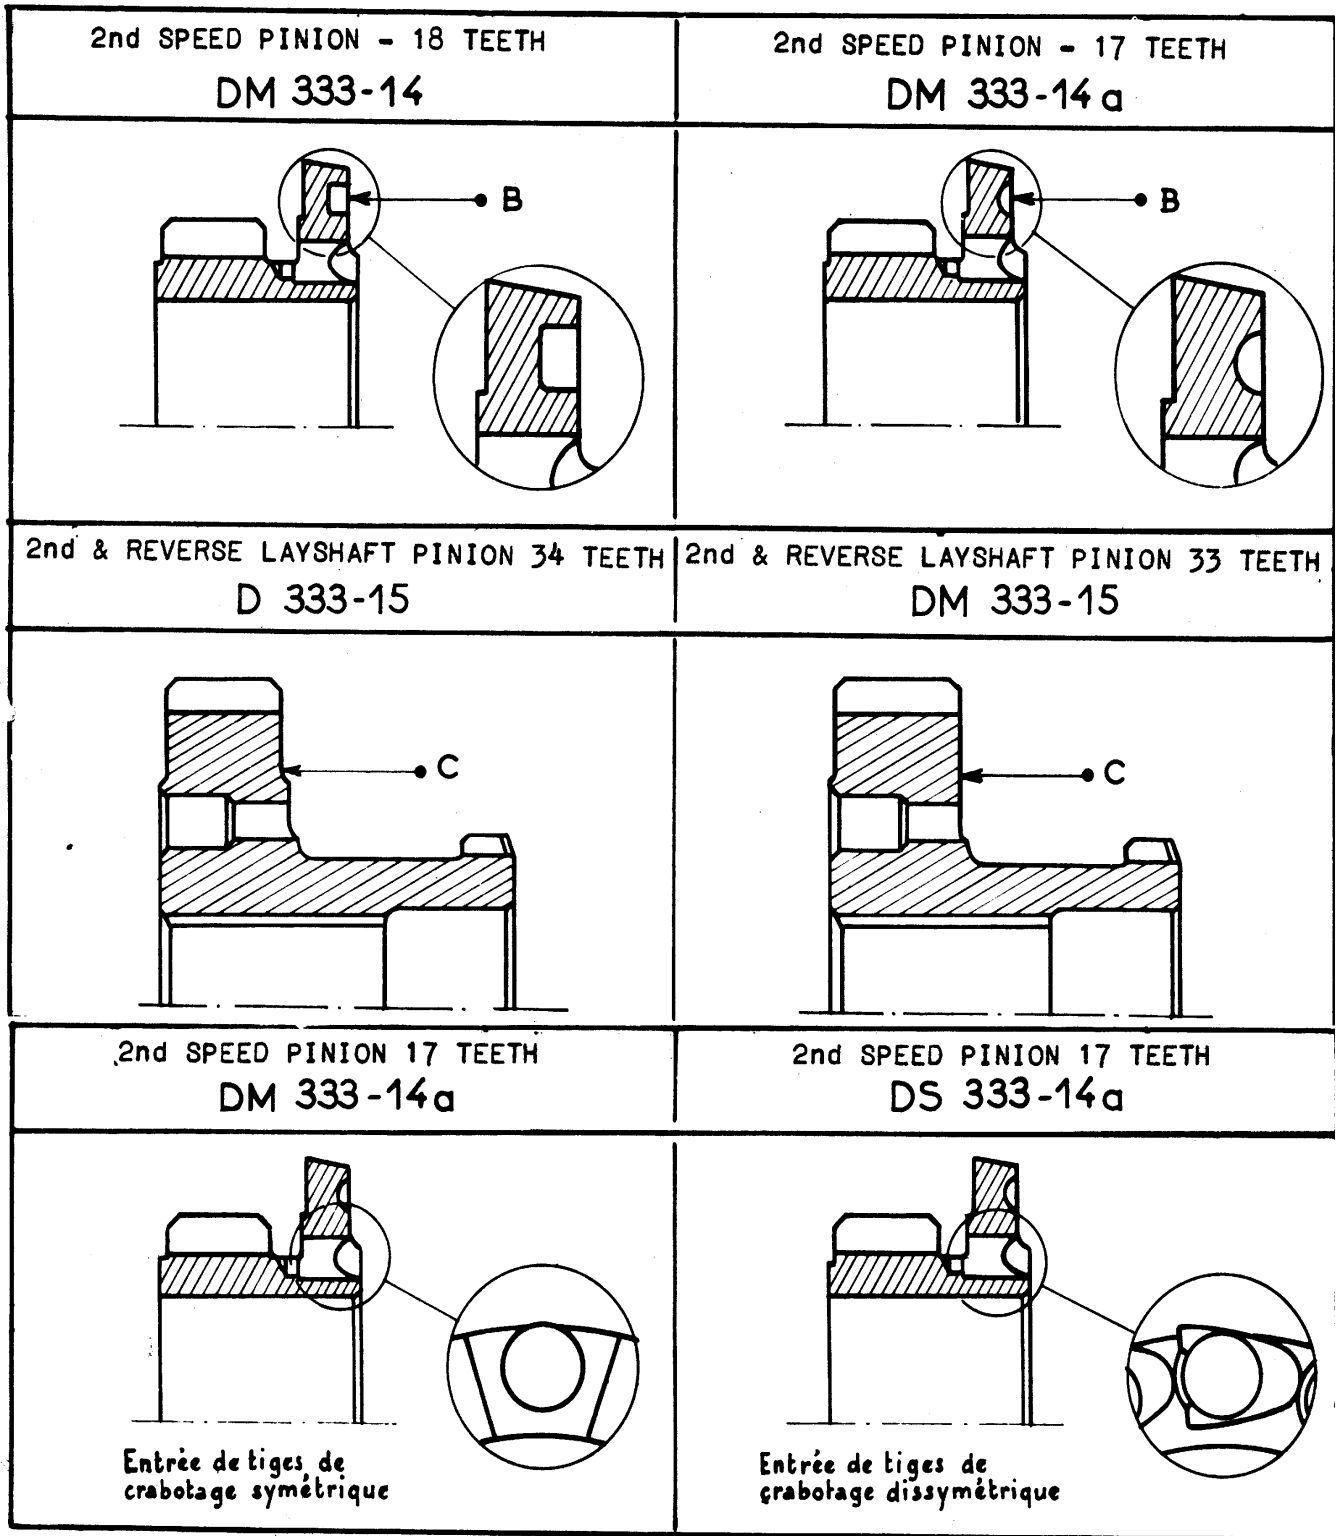
Fig. 1

a) 2nd speed pinion (17 teeth). The difference between DM 333-14A and DS 333-14A is in the pilot openings (see figure 1).

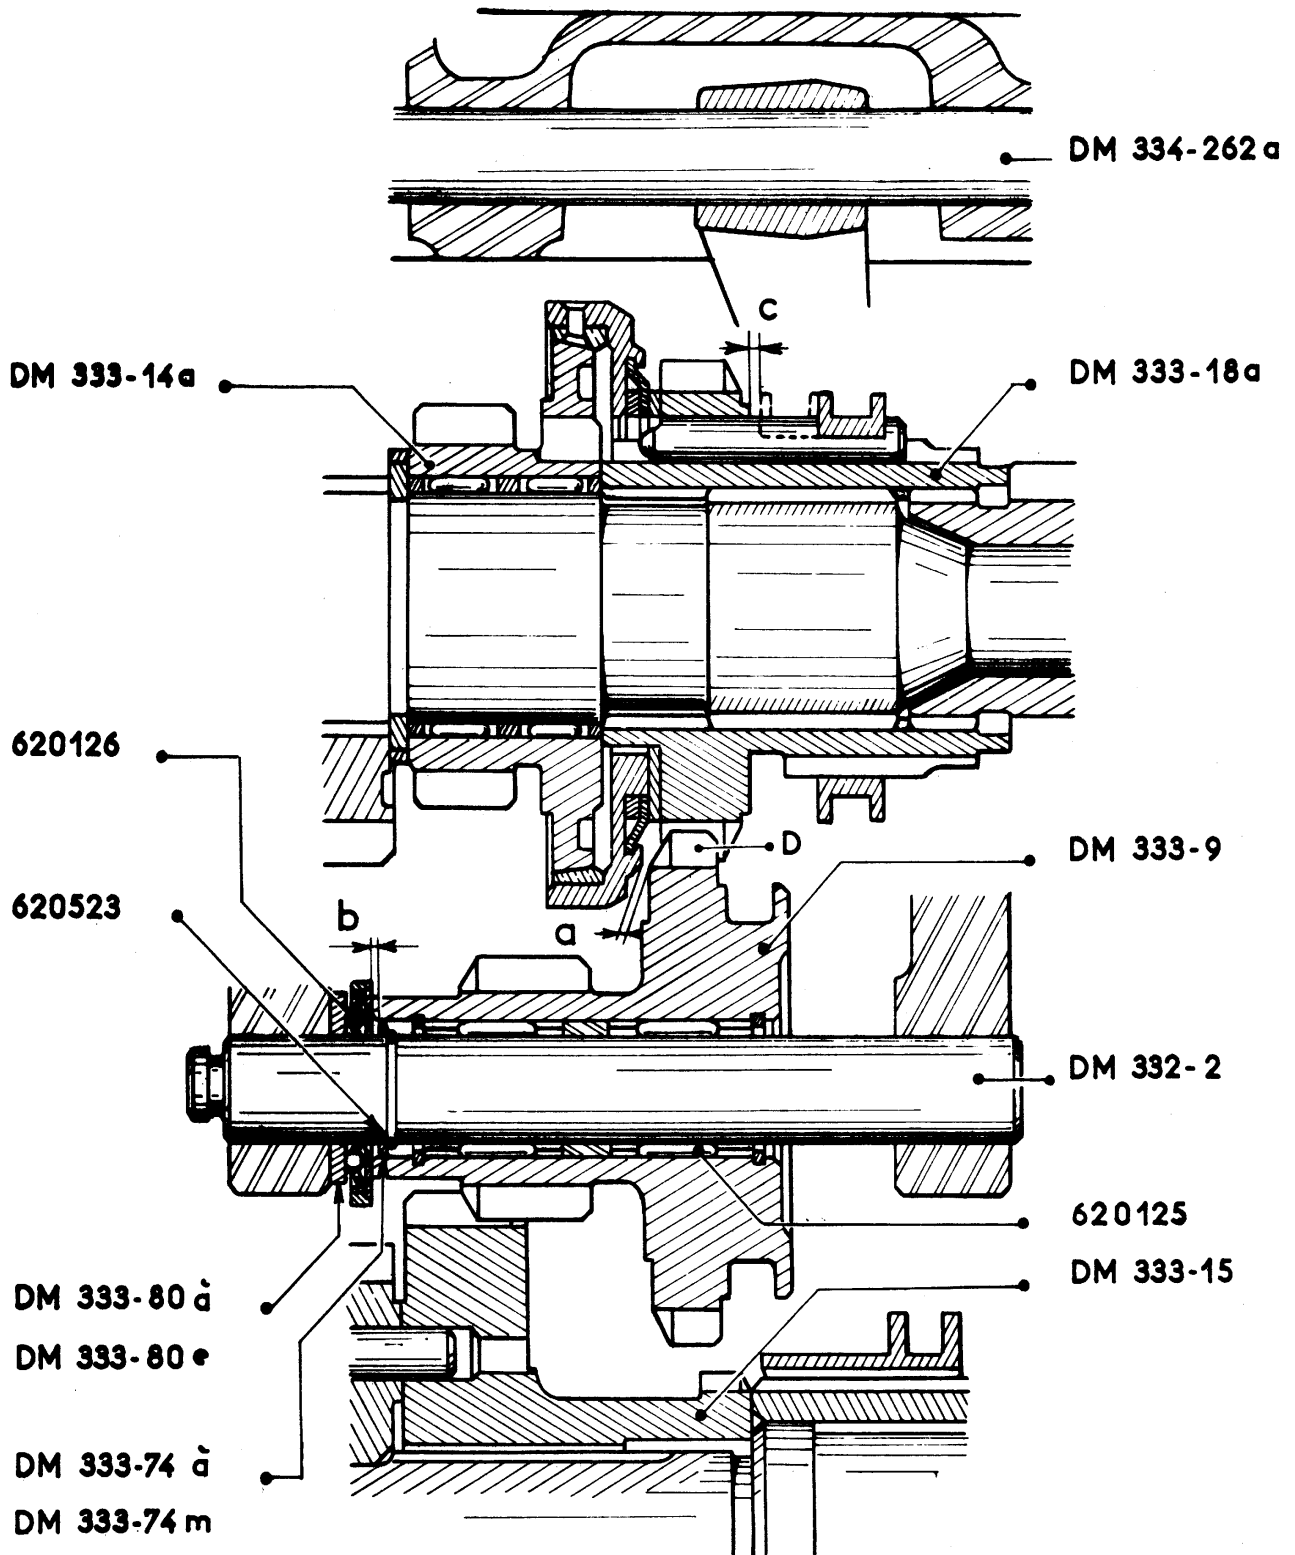
Fig. 2 REVERSE GEAR

a) Clearances to be respected (see figure 2).

Clearance "a" 0.0118" to 0.0315" between 2nd speed synchro and tooth D of the sliding reverse assembly.

Clearance "b" 0.0039" to 0.0197" between the thrust washer and circlip.

Clearance "c" 0.0787" to 0.0197" between 2nd speed sliding collar and reverse gear.

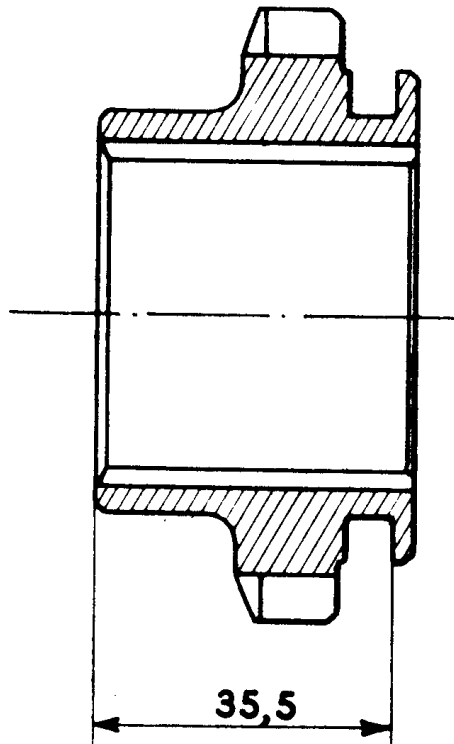
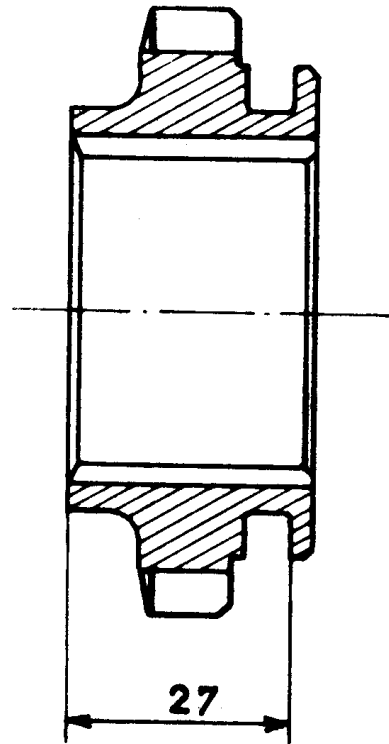
The DS 19 gear boxes are now equipped with a narrower sliding reverse pinion.

The former and new pinion have the same part Number: D 333-9 and are interchangeable.

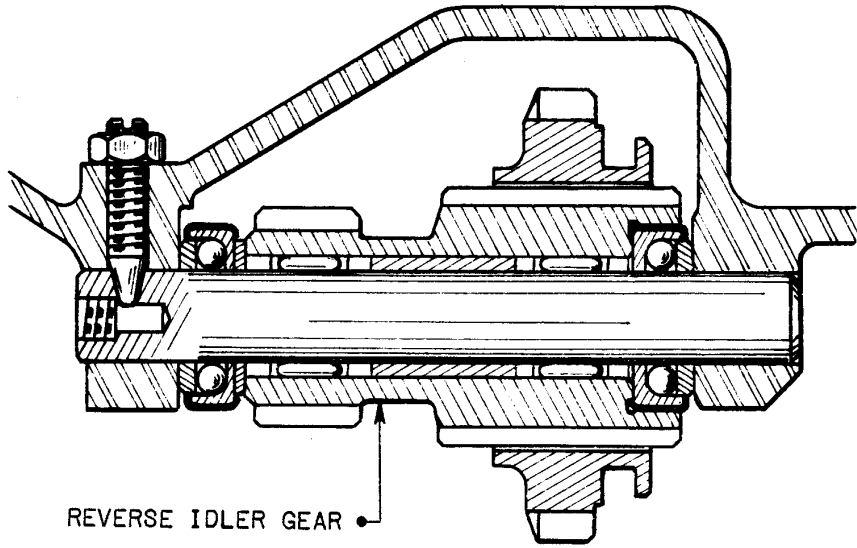
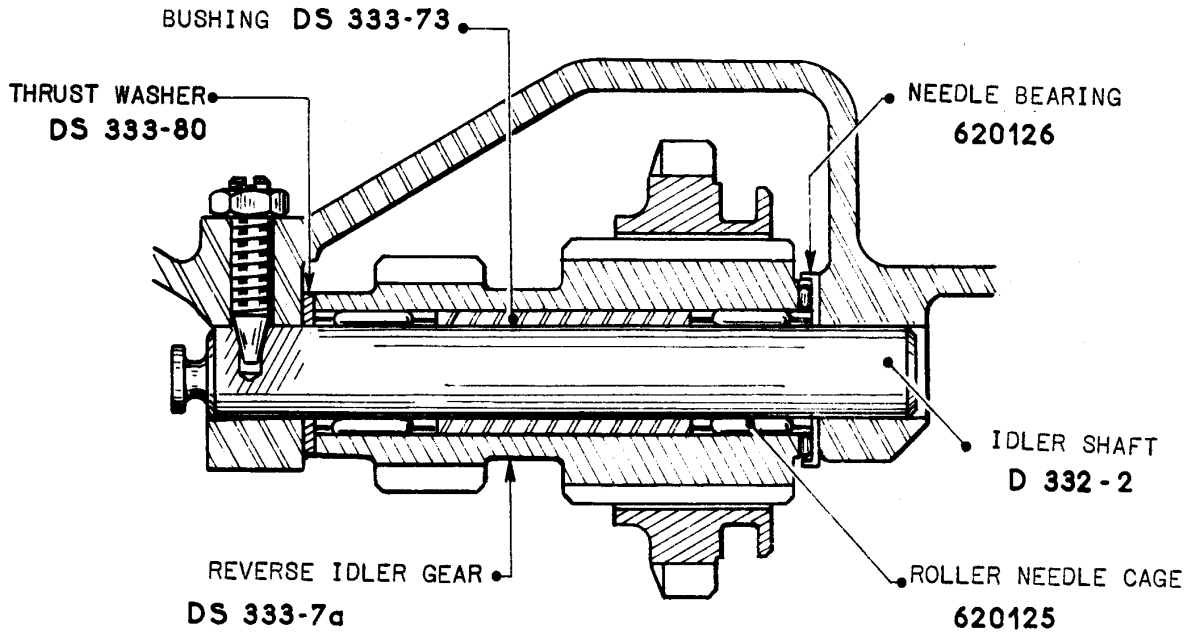
On DS 19 Model, the assembly of the reverse idler gear (10 teeth) has been modified as follows

- 1) Both ends roller bearings of the previous assembly are replaced by a needle bearing # 620126 and a thrust waeher # DS 333-80. Thus, the idling gear, the distance sleeve and the roller needle cages are also modified.
- 2) A conical seat on the idler shaft enables the removal of the latter, rendering the previous end threaded hole unnecessary (see sketches).

IMPORTANT: The adjustment of the end play is no longer required. The play is pre-set according to the tolerance of the components and must be mounted with coppered side facing the idler gear.

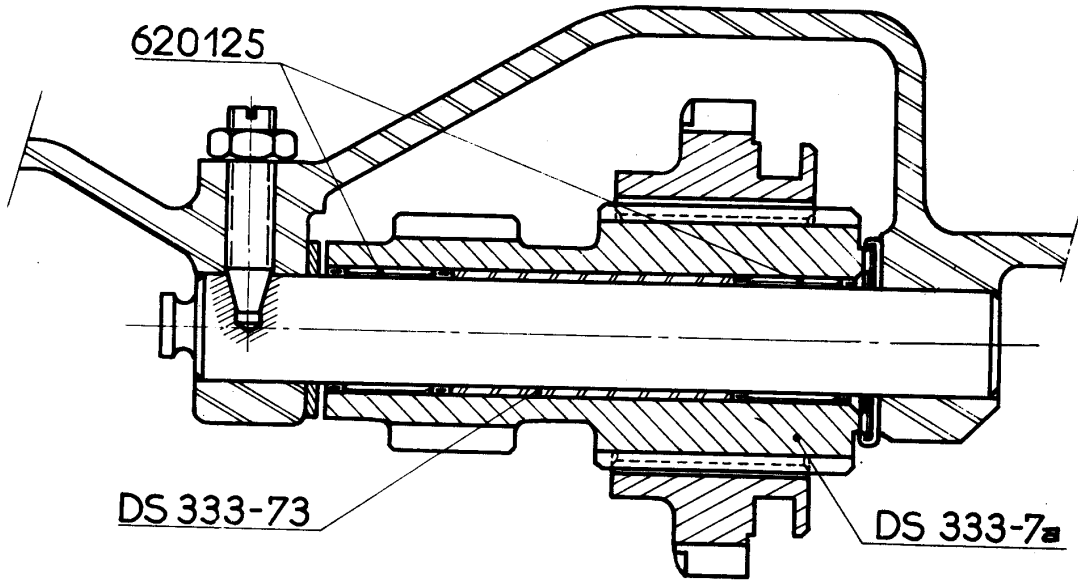
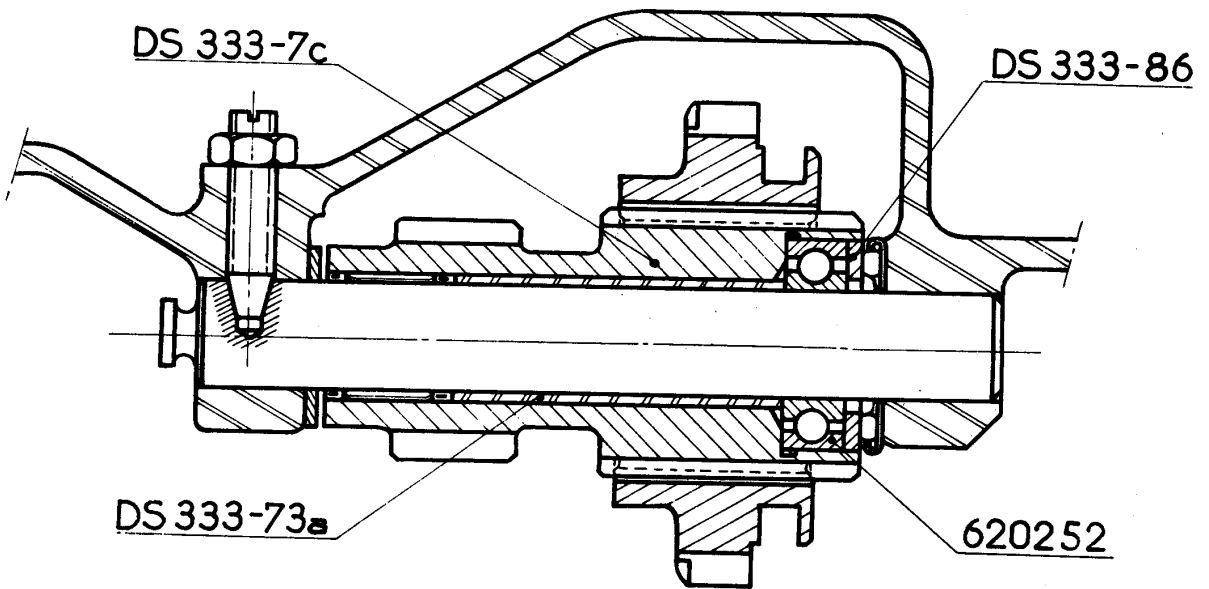
REVERSE IDLER TRAIN

The reverse idler train has been modified.

The needle bearing 620125 next to the thrust bearing has been replaced by a roller bearing (See sketches).

It is possible to install the new idler train on the old type gear box providing that above listed parts are replaced.

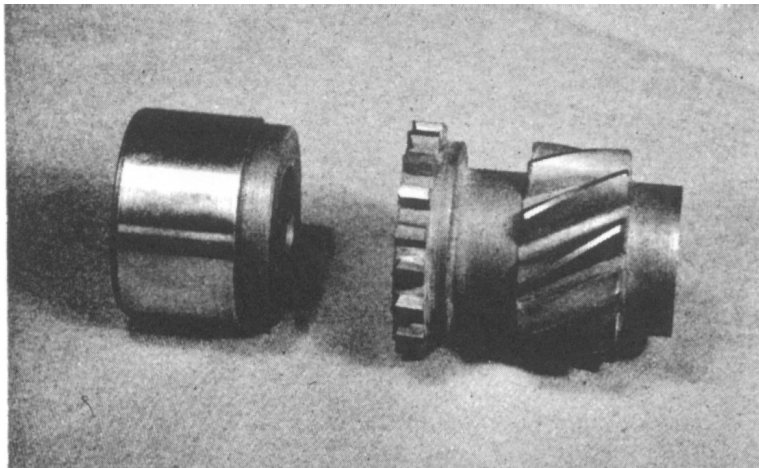
The sleeve D 333-75A is modified. It has now a shoulder as shown in figure below.

The new sleeve is interchangeable with the previous one without any further modification. For the assembly, the shoulder on the sleeve must face the reverse idler gear D 333-7A, as shown below.

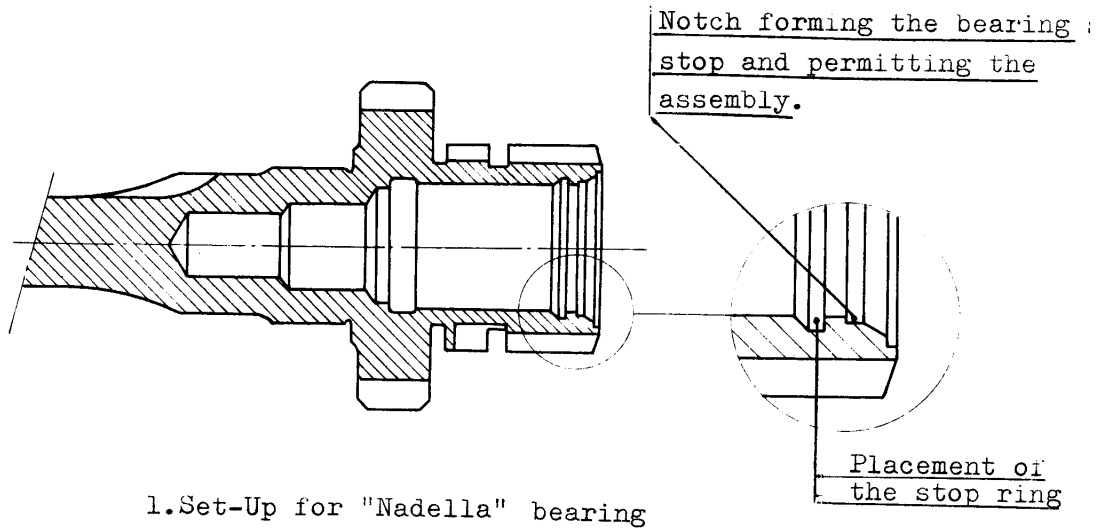
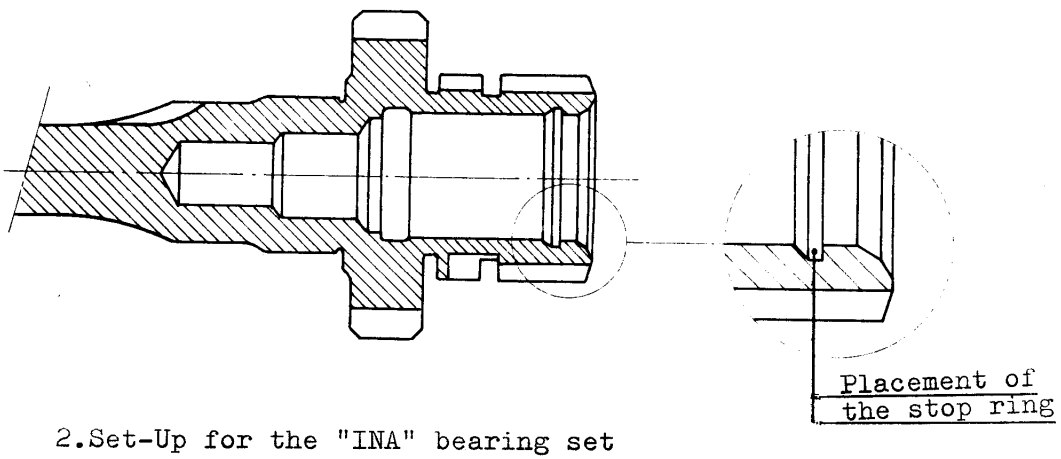
M A I N S H A F T

The groove, machined in the shaft, at the entrance of the bore designed to seat the "NADELLA" bearing, is replaced by a chamfer which facilitates mounting of the stop ring No. 620534 (see figure).

It is possible to mount the "INA" bearing in a shaft having a groove. Be sure the stop ring seats well in the groove after mounting.

It is not possible to mount a "NADELLA" bearing in a new shaft having only a chamfer.

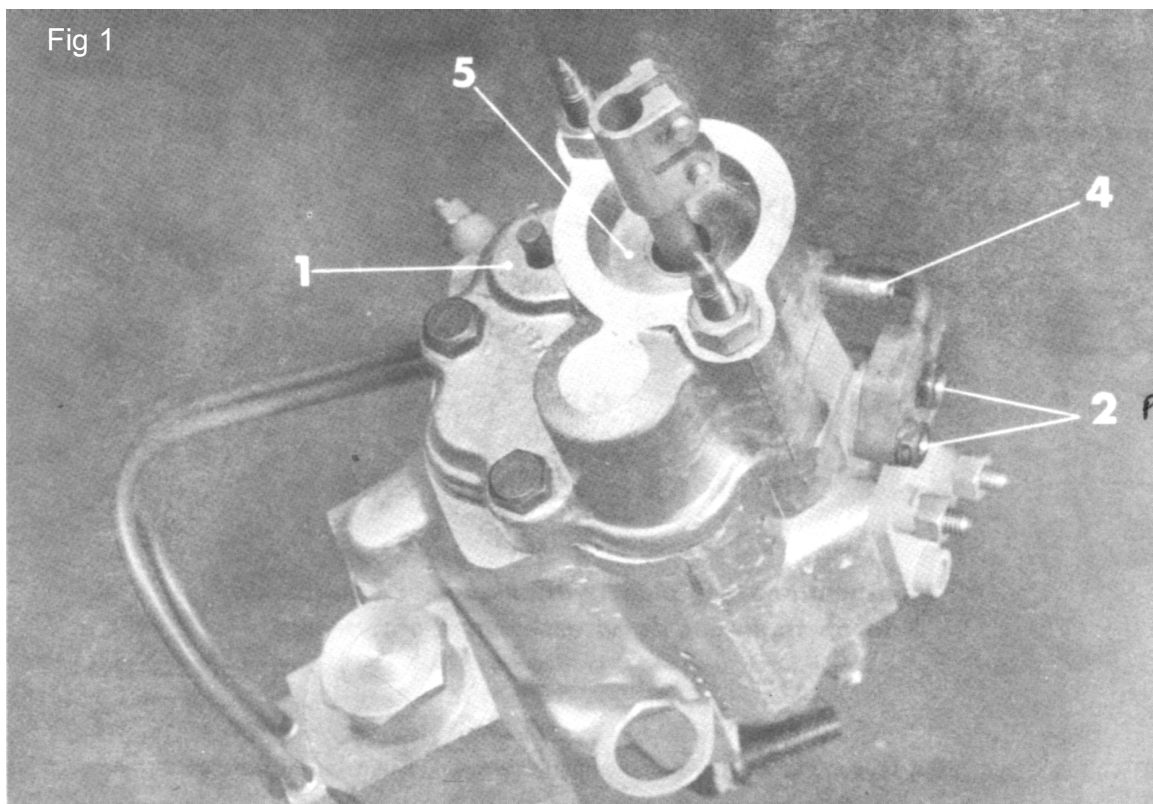
- Creation of an exterior casting embossment at the location of the manual clutch control valve (1 fig.1)
- Replacement of the two studs fastening the shift corrector tubes by two screws (2 fig.1)
- Fastening the front cover (3 fig.2) at six points instead of four.
- Mounting of a leakage drain tube (4 fig.1) on the rear cover.
- Addition of a partition cast (5 fig.1) in the passage of the gear selector valve.
- Abolition of the seal between the sleeve and the gear selector valve.
- Addition of the seal ring (6 fig.3) between the manual clutch control housing and the rear cover.
- The end plug of the automatic clutch control pistons housing is of steel (instead of aluminum) mounted with a sliding fit in the housing.

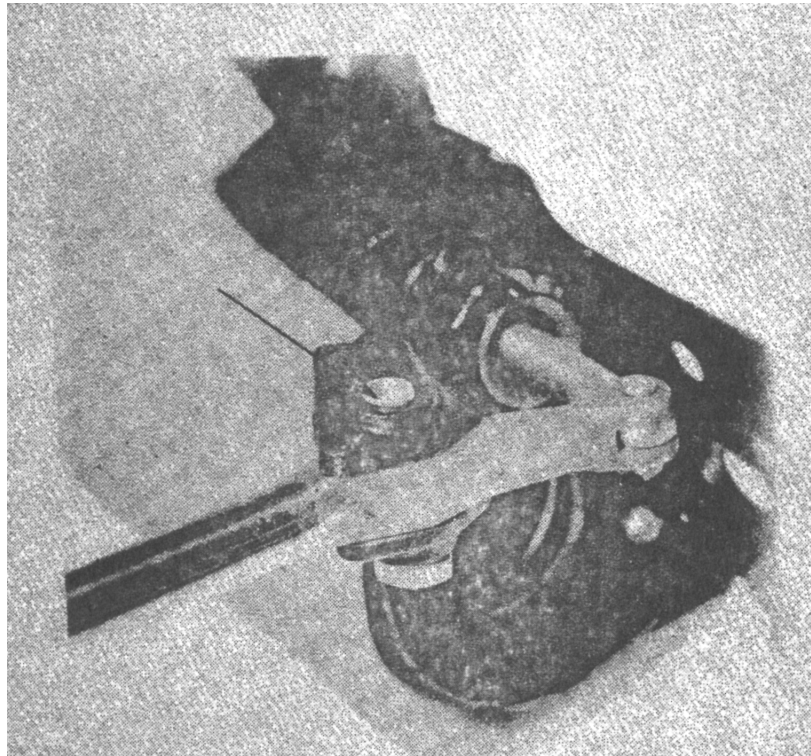
The shifting control shaft (DJ 334-4) of the above-mentioned models is modified. The shouldered pin of the shift lever at the dashboard is replaced by a threaded pin. The lower part of the stirrup straddling the shift lever is tapped to receive the threaded pin.

After setting in place, the end of the pin is expanded to prevent its rotation.

To remove the threaded pin, loosen it. The expanded collar at the end of the pin will break itself. When remounting the pin, tighten it just to the point where the stirrup binds the lever. Expand, or peen, the end of the pin, then loosen it slightly until the lever moves freely in the stirrup. It is possible to replace the old type shift control by a new type provided the shouldered pin is replaced by the threaded pin.

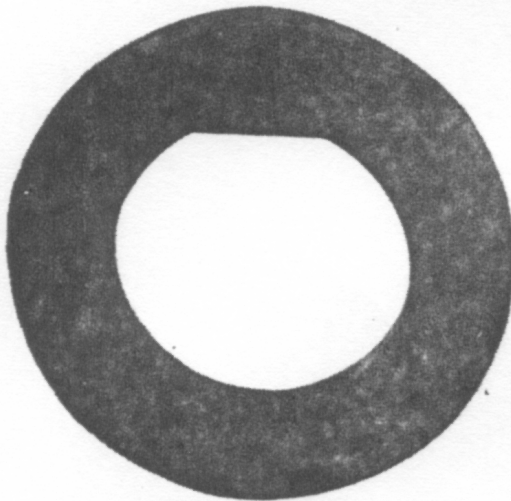
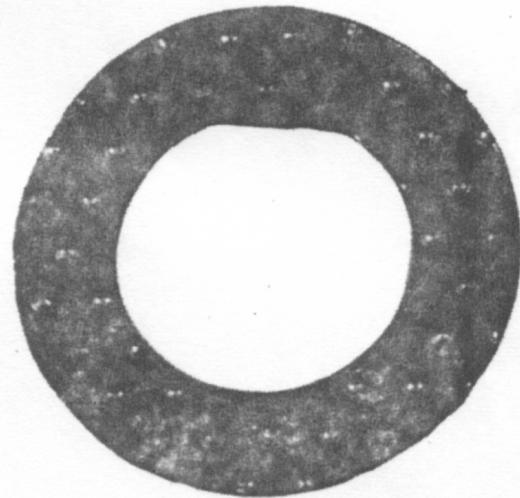
The stationery bronze thrust washer A 333-95, 4mm (0.158") thick at the front of the intermediate gear train, is replaced by a steel washer AZ 333-95b, 2.40mm(0.094") thick coated with an anti-friction alloy.

The intermediate gear train, A 333-5, is replaced by the gear train AZ 333-5 on which the posture of the surface facinh the thrust washer has been modified according to the thickness of the new washer AZ 333-95b.

SERVICE: The washer AZ 333-95b CAN BE MOUNTED ONLY with the intermediate gear train AZ 333-5.

IMPORTANT: The thrust washer surface having the spherical pitting must **IMPERATIVELY** be mounted facing the intermediate gear train.
