**TECHNICAL
INFORMATION**

CITROËN CARS CORPORATION

INDEX TO TRANSMISSIONS / DRIVESHAFTS

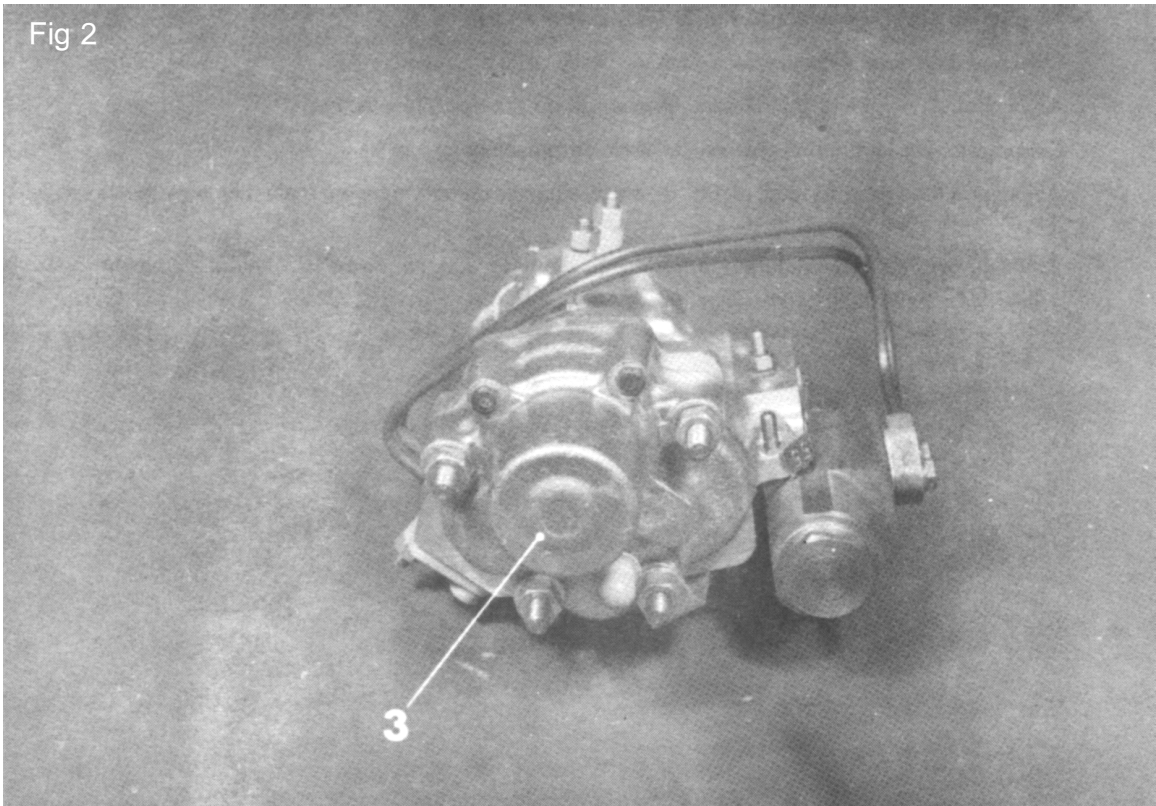
Fig 2

- Creation of an exterior casting embossment at the location of the manual clutch control valve (1 fig.1)
- Replacement of the two studs fastening the shift corrector tubes by two screws (2 fig.1)
- Fastening the front cover (3 fig.2) at six points instead of four.
- Mounting of a leakage drain tube (4 fig.1) on the rear cover.
- Addition of a partition cast (5 fig.1) in the passage of the gear selector valve.
- Abolition of the seal between the sleeve and the gear selector valve.
- Addition of the seal ring (6 fig.3) between the manual clutch control housing and the rear cover.
- The end plug of the automatic clutch control pistons housing is of steel (instead of aluminum) mounted with a sliding fit in the housing.

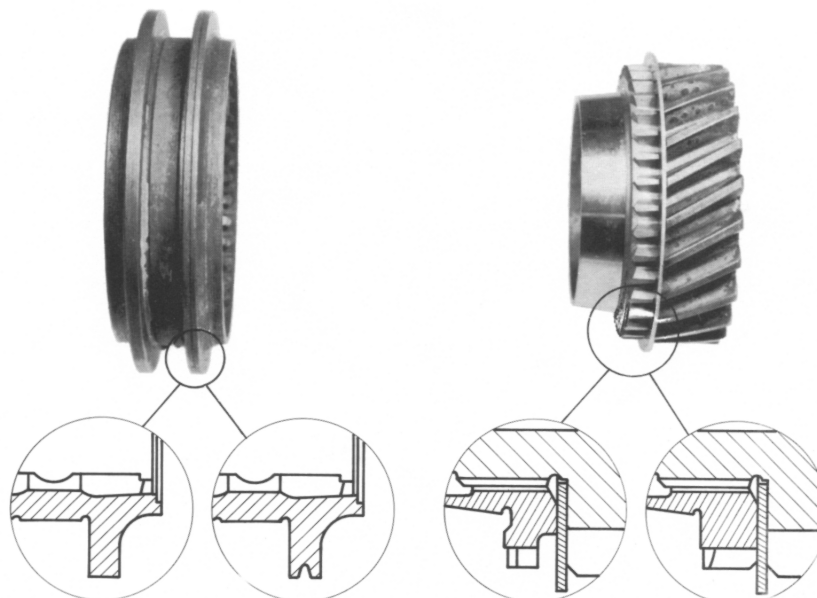
The new synchronizer, DX 335-06a, and the new 3rd speed pinion, DX 333-8b, must necessarily be mounted as an assembly. It is not possible to mount one of the new parts with either of the old parts.

Until the supply is exhausted, it is possible to use the old parts on models with hydraulic shifting control (Aero Super). The new parts should be used for the models with mechanical shifting control (Grand Route).

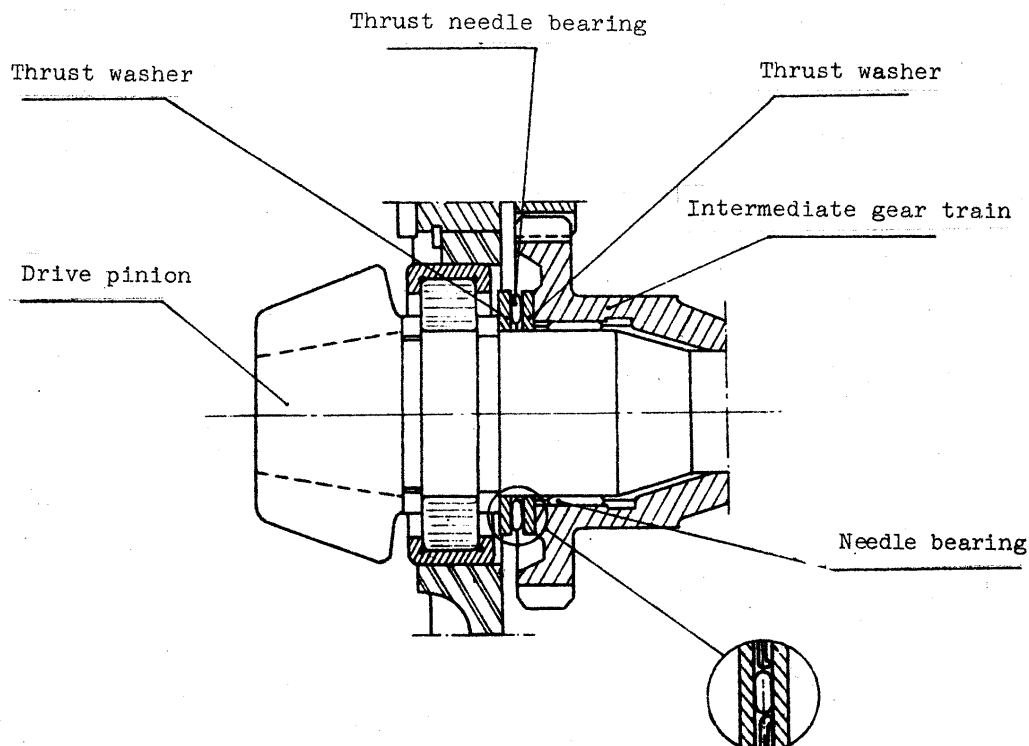
The front caged needle bearing of the intermediate gear 620202 (25x29x18.2) is replaced by a caged needle bearing 620319 (29.5x33.5x18.2)

SERVICE: The new parts can only be mounted as an assembly in the gear boxes of cars produced earlier. The instruction for reconditioning and adjustment of the new gear boxes are identical to those outlined in the Shop Repair Manual No.490, 1965 Edition.
